**Canyon Fuel  
Company, LLC**

**Sufco Mine**

**ANNUAL MINESITE PRIMARY SEDIMENTATION POND  
CERTIFICATION -- 2010**

Minesite Primary Sediment Pond Annual Inspection Report

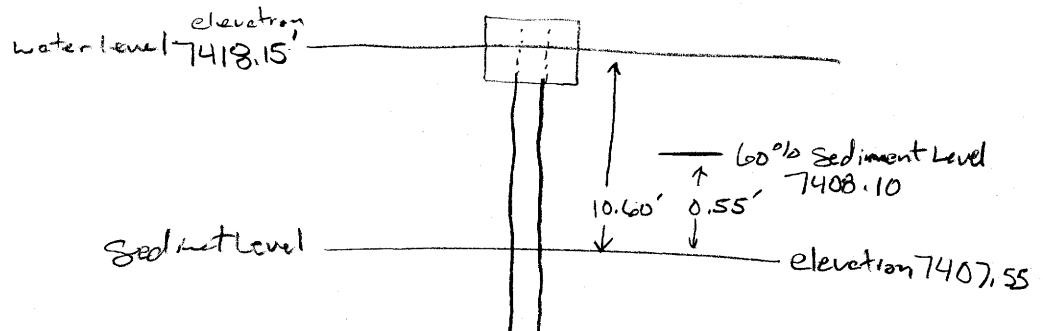
10. Drawing

minor gullies forming on west slope from 2009

There was some minor erosion on the road to the pond that was repaired

The pond sediment level is 0.55' Below 60% Sediment Level the pond should be cleaned in 2011.

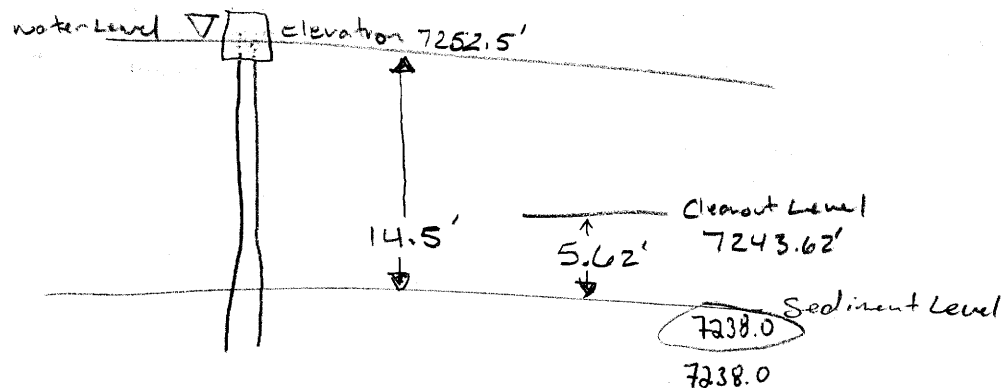
10. Drawing

There is some minor erosion  
None. Constructed in 2010

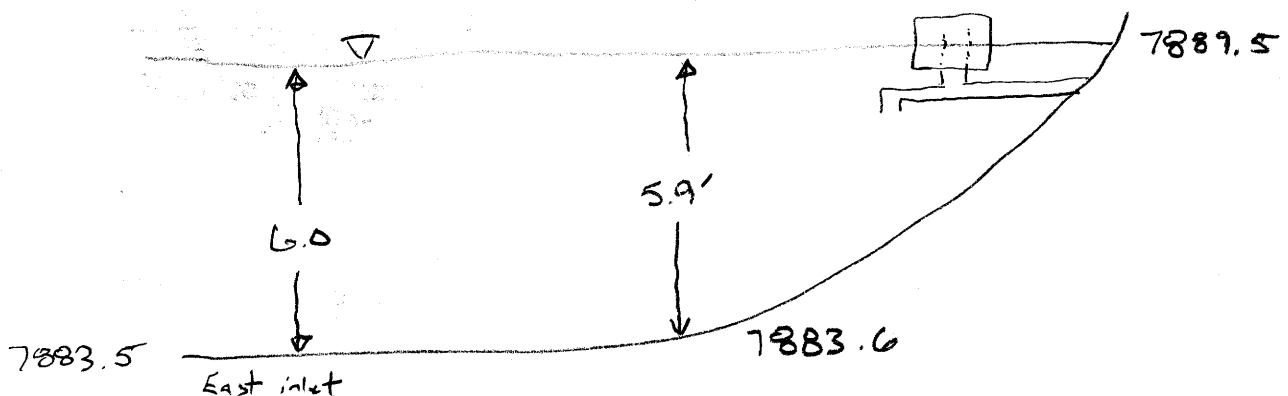
10. Drawing

No evidence of discharge

Decent Pond OK - No erosion, No structural weakness

Spillway clear
